FULL RESERVE STUDY

Park Tower Condominium Association

Chicago, Illinois
February 13, 2020

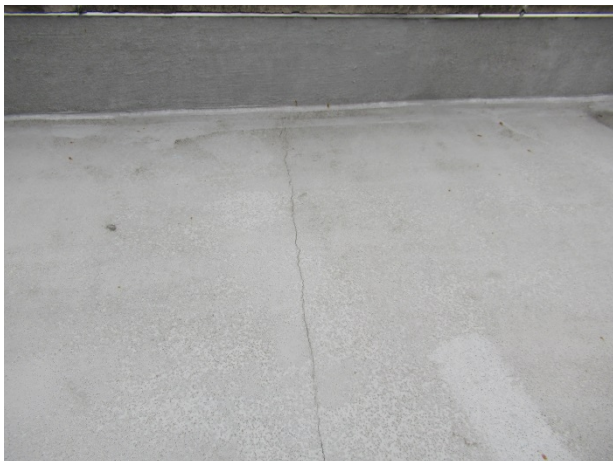
Crack at waterproof coating at 2nd floor concrete roof system

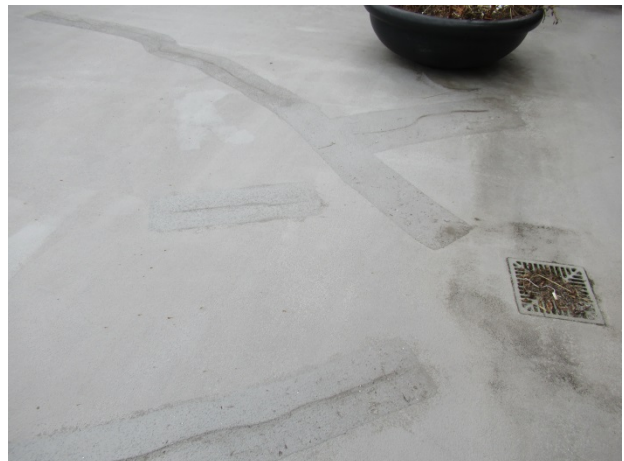
Crack repairs at waterproof coating at 2nd floor concrete roof system

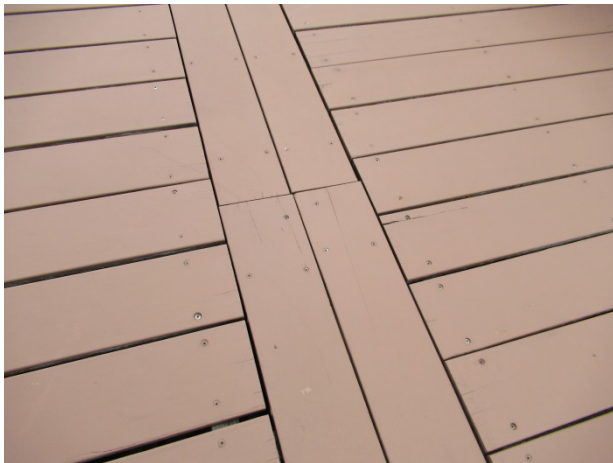
Weathered wood at 2nd floor sun deck

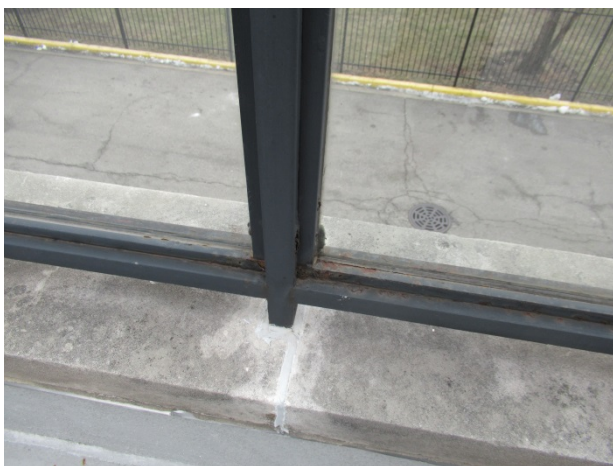
Frame corrosion at railing east of pool area

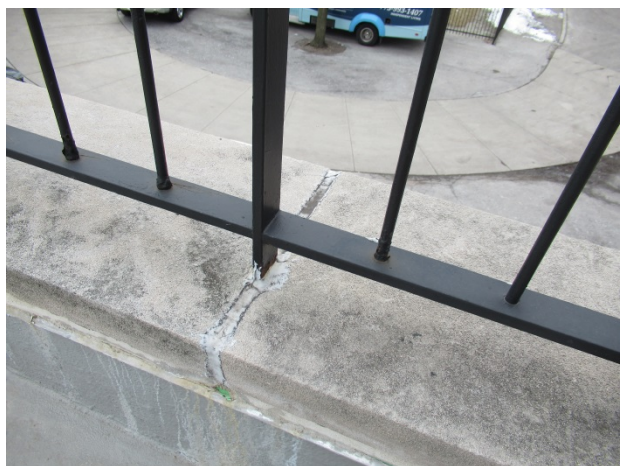
Inset post and steel rust at 2nd floor roof perimeter

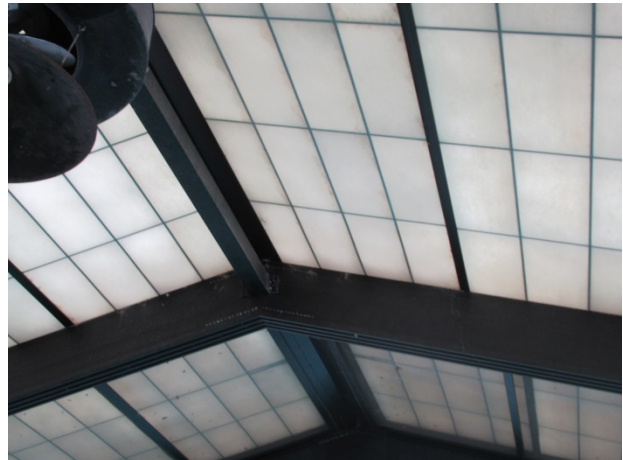
Evidence of water infiltration at pool enclosure

Useful Life: The enclosure panels have a useful life of up to 40 years with the benefit of repairs and replacement of sealants every 10- to 15-years. The structural frame has an indeterminate remaining useful life.

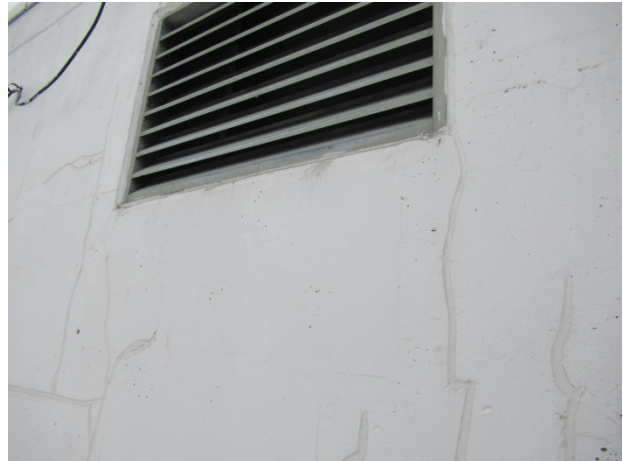
Repaired cracks at penthouse concrete

Useful Life: We recommend concrete inspections, coating applications and repairs up to every 12 years.

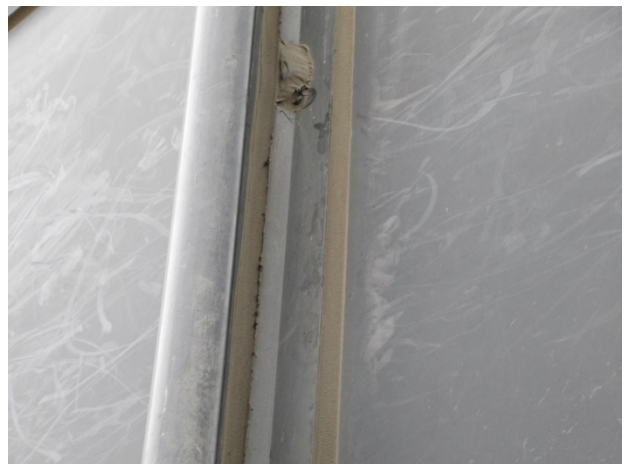
The curtain wall system exhibits areas of sealant deterioration. The spandrel panels and frames exhibit dirt/pollutant build-up.

Sealant deterioration at metal/metal interface

Useful Life: Properly maintained curtain walls have an indeterminate remaining useful life with the benefit of timely maintenance and repairs. We recommend inspections, sealant replacements and repairs up to every 12 years. We also include periodic expenditures for inspections and interim water infiltration remediation. We opine that complete replacement would require means other than reserves to fund.

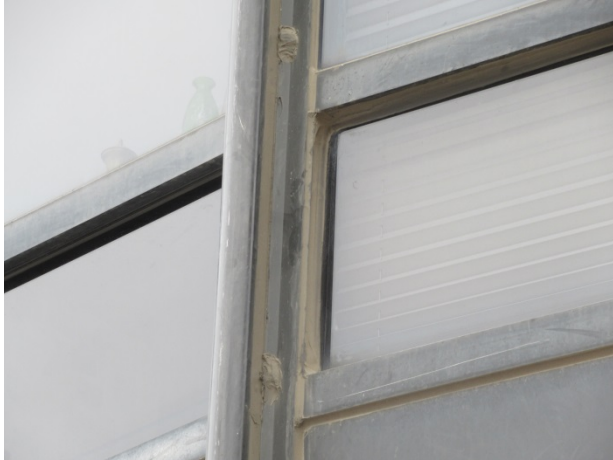
Sealant at metal/glass and metal/metal interfaces

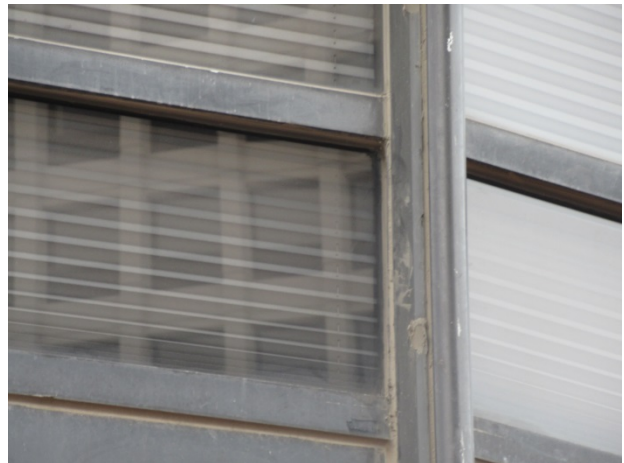
Frame color variations/dirt build-up

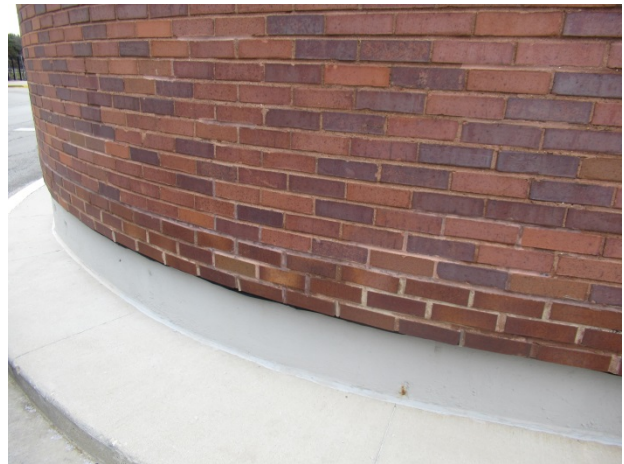
Masonry deterioration and lack of flashing at wall base

Useful Life: We advise a complete inspection of the masonry and related masonry repairs up to every eight years to forestall deterioration.

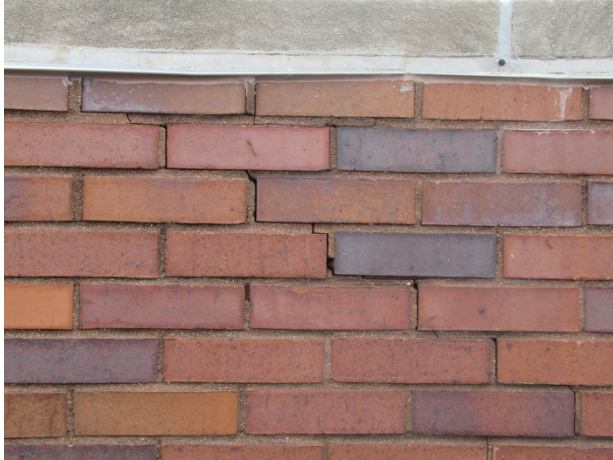
Masonry crack at parapet wall

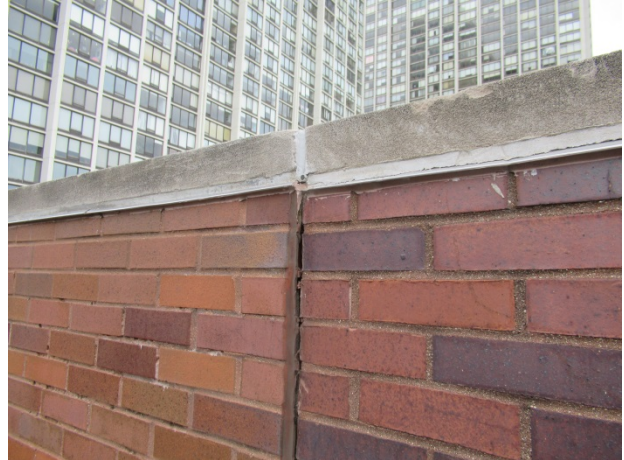
Masonry deflection at parapet wall

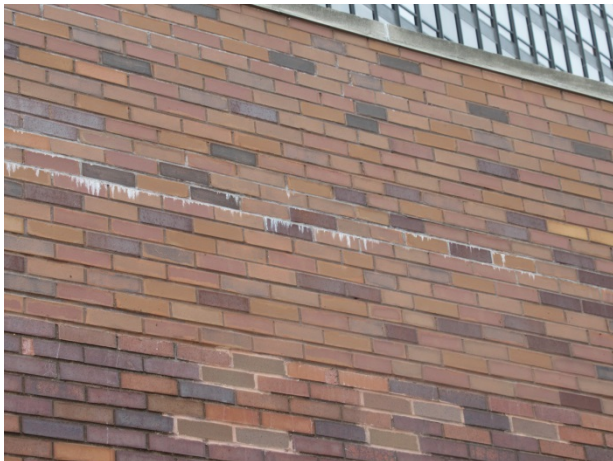
Evidence of water infiltration at masonry wall

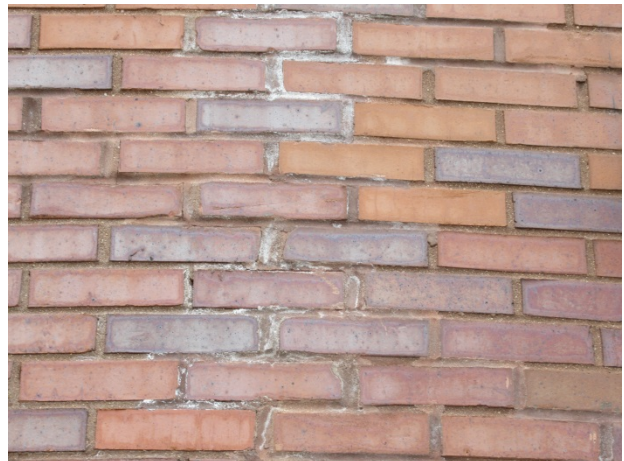
Evidence of water infiltration at masonry wall

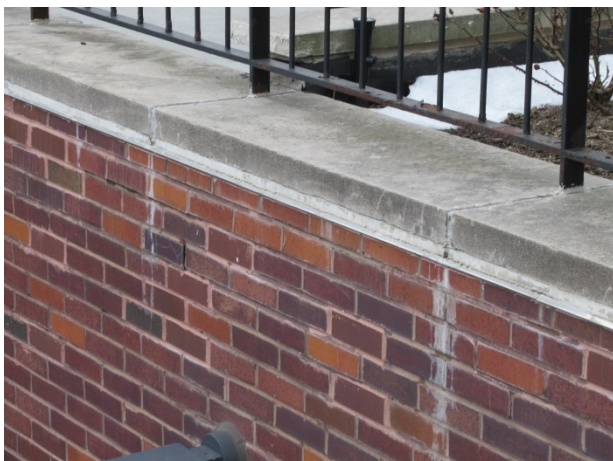
Evidence of water infiltration at masonry wall

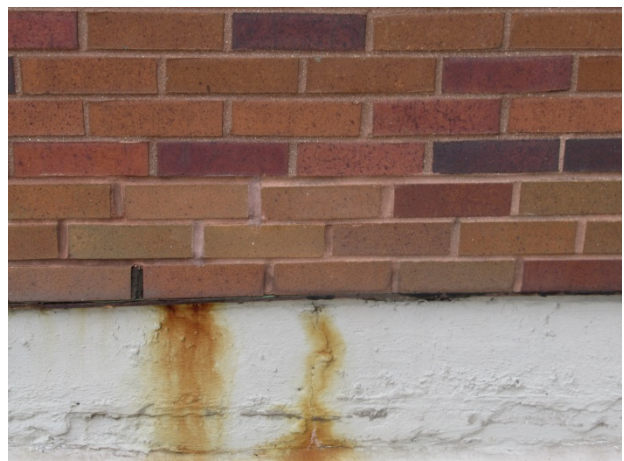
**Evidence of water infiltration at masonry wall
and lack of base flashing**

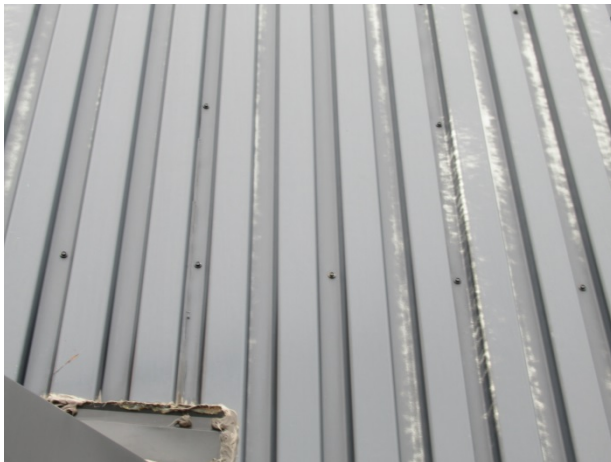
Metal siding finish damage

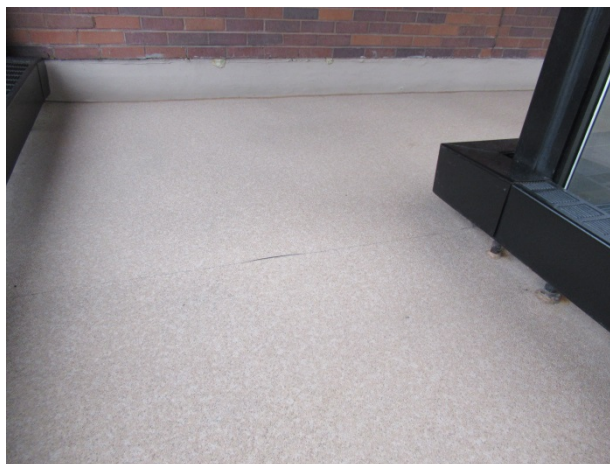
Raised seam at walkway flooring

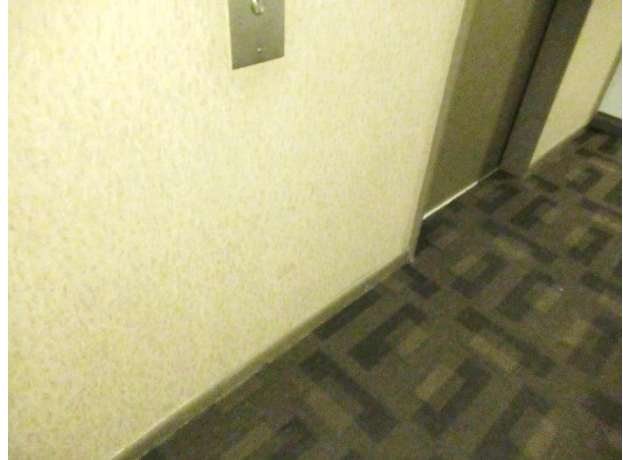
Typical damage at elevator foyer wall covering

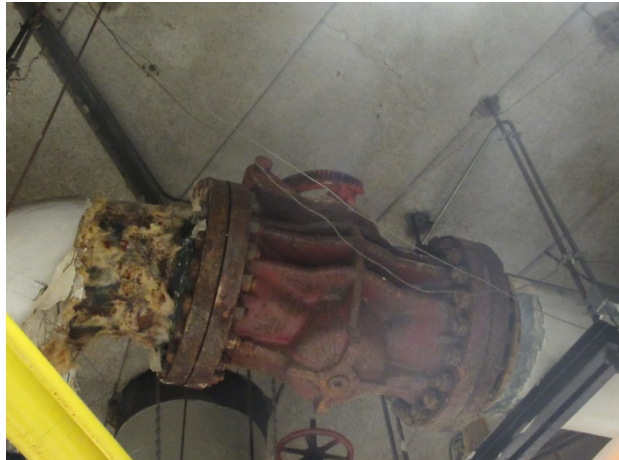
Condition: Reported satisfactory (An exception includes a large diameter valve for the building heating system in the boiler room that will require replacement in the near term, as noted in the narrative “**Heat Exchangers**”.)

Valve to be replaced in near term

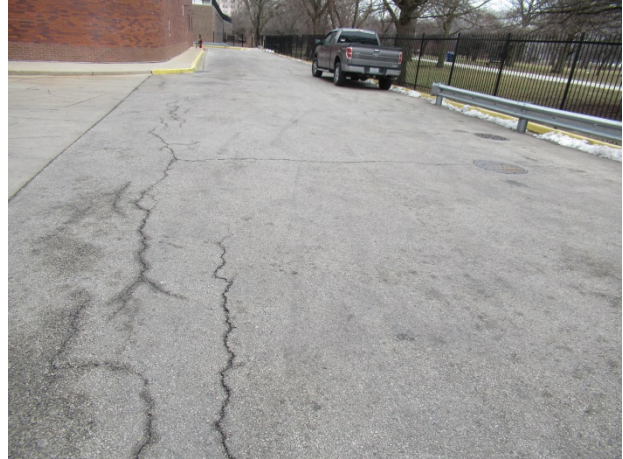
Pavement deterioration at east perimeter

Useful Life: 15- to 20-years with the benefit of timely crack repairs and patching through the operating budget

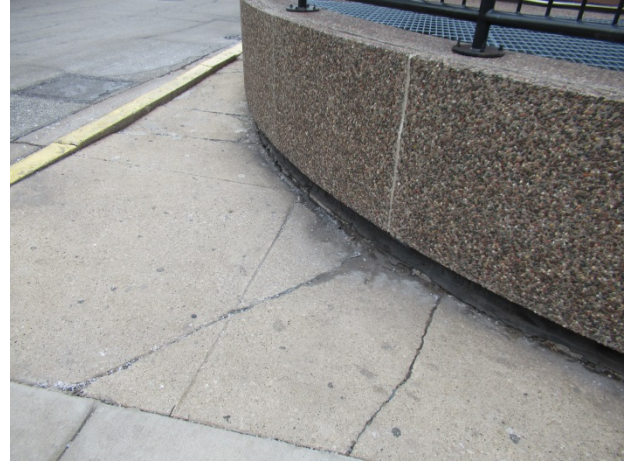
Concrete cracks

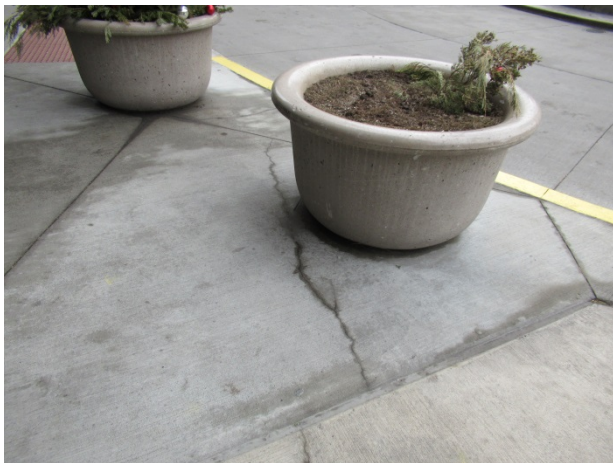
Crack in concrete at plaza

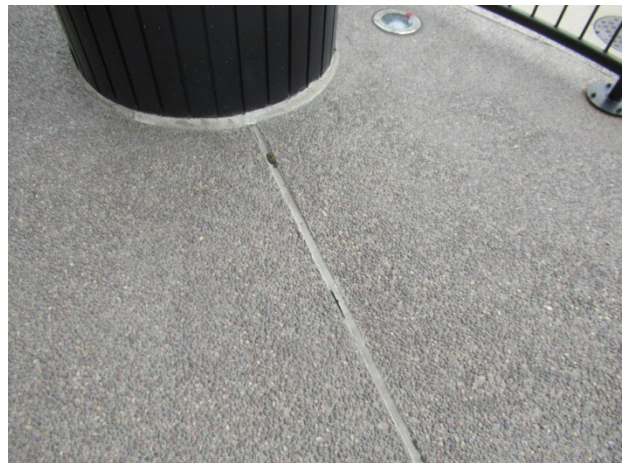
Sealant deterioration at plaza

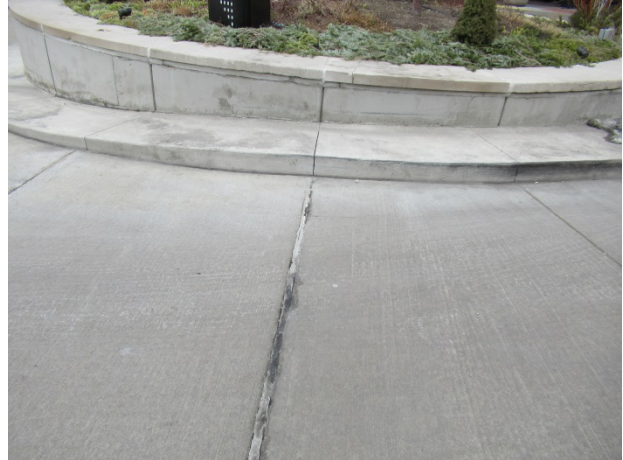
Sealant deterioration at circle driveway

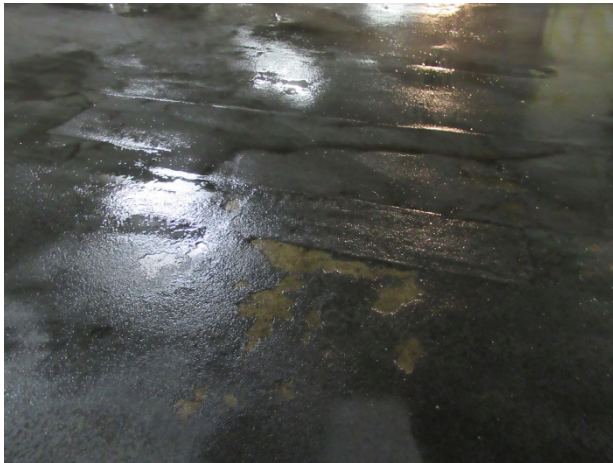
Traffic coating deterioration/damage at elevated garage floor

- Repairs to the 1P elevated garage floor top and underside concrete
- Replacement of the traffic coating at the 1P garage floor
- Cracks repairs and patching at the 2P garage floor
- Drain repairs

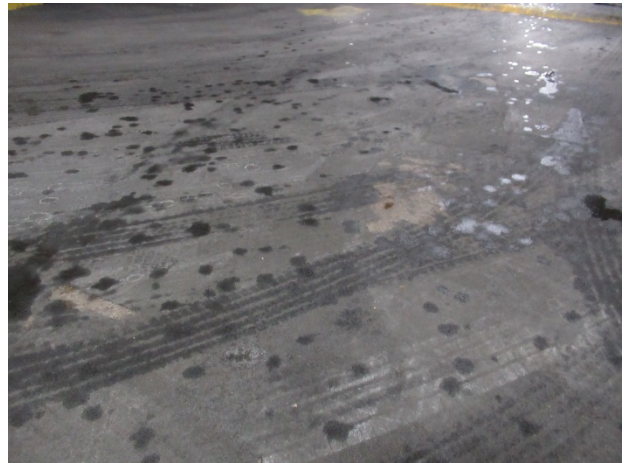
Traffic coating deterioration/damage at elevated garage floor

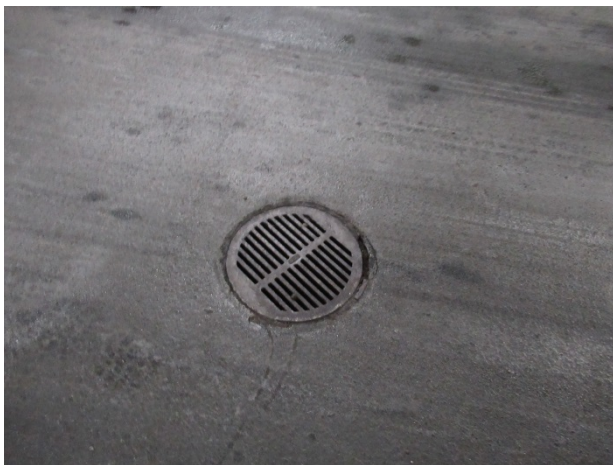
Traffic coating deterioration/damage at elevated garage floor at drain

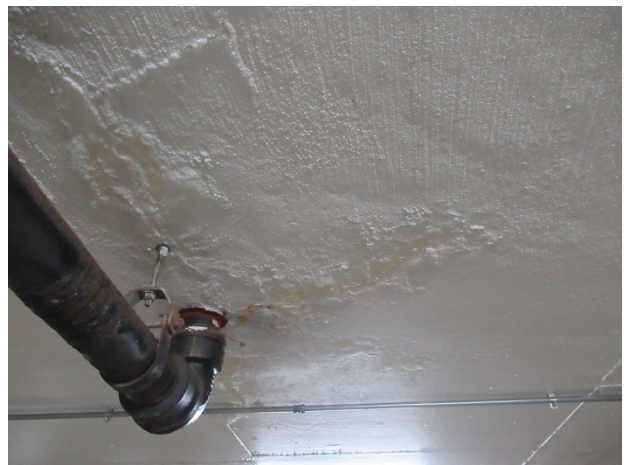
Evidence of water infiltration beneath elevated garage floor

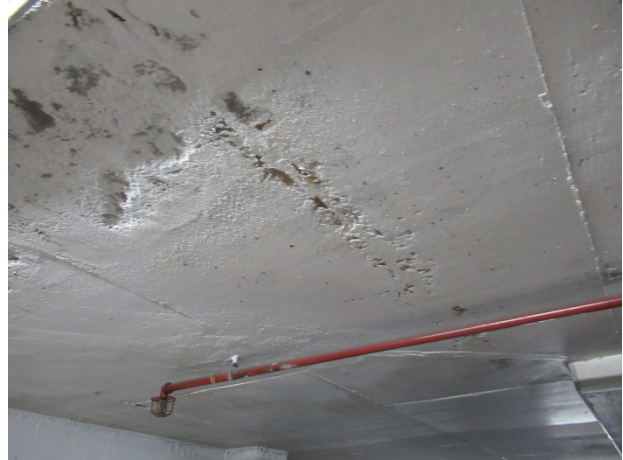
Typical concrete repairs beneath elevated garage floor

Useful Life: Repairs to the various concrete surfaces up to every 10 years
