Recently Remodeled New Culinary Confines for Unit Owner in 05 Tier Unit!

New Kitchen for 05 Unit

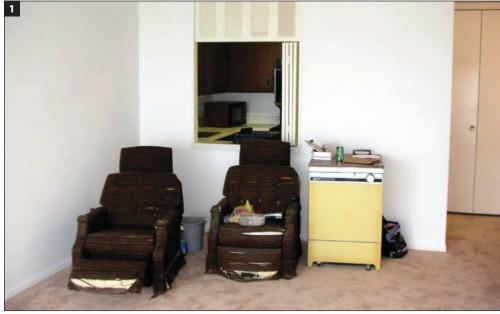
In 2012, a new owner found himself with this view of his 05 tier kitchen. (See photo 1 at right) Hmm!

John Doe (JD) knew that virtually any interior wall in our residential units can be modified or eliminated. Down came the interior kitchen walls, while leaving electrical and phone wiring temporarily in place.

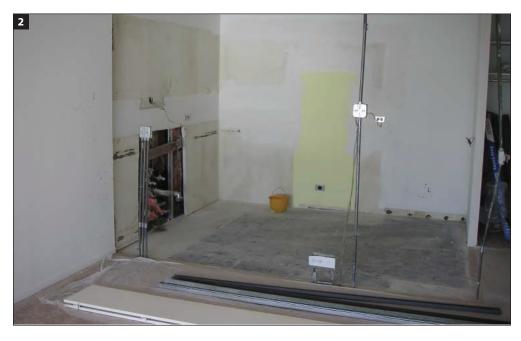
Aluminum framing for a new soffit containing phone wire and over-counter pendant lights (See photo 2 at right).

While a growing number of residents use cell phones, the building still requires that the main wired lines remain intact, from the ground floor through the 55th floor. So JD couldn't just slice off his section. Rather, he had his electrician splice in a piece of 25 pair phone cable long enough to detour under the counter base cabinets, up the wall, and back through the soffit, to connect again with the main line running up to the unit just above.
