FULL RESERVE STUDY

Park Tower Condominium Association

Chicago, Illinois
February 13, 2020

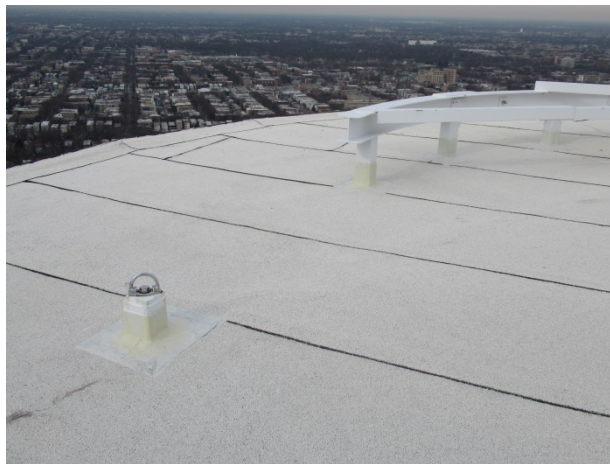
- Electrical Systems, Wires and Bus Bars, Common (Indeterminate Remaining Useful Life)
- Foundation
- Pipes, Interior Building, Fire Standpipes and Gas Supply (Indeterminate Remaining Useful Life)
- Pipes, Subsurface Utilities
- Pool Structures, Main and Outdoor
- Roof Anchors/Davits and Remaining Track System (Installed 2017) (We assume timely inspections and repairs through the operating budget.)

Roof anchor and original track system

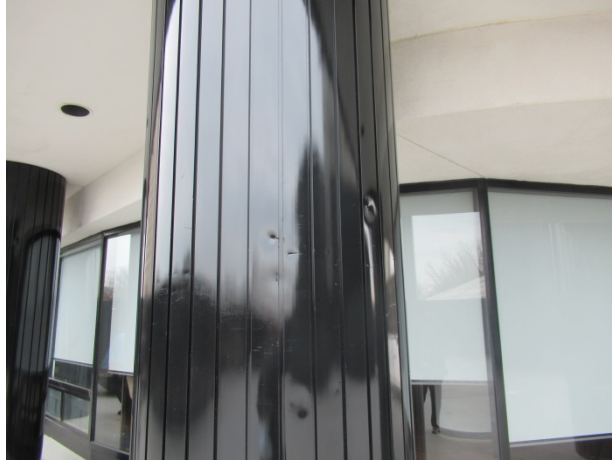
- Air Handling Unit, Laundry Room (Coils Replaced 2014) (Including Return Air Fan)
- Asphalt Pavement, Crack Repair, Patch and Seal Coat Applications
- Boiler Stack
- Boilers, Main, Condensate System
- Chemical Treatment Systems
- Column Cladding (The Association maintains the cladding through an annual service contract.)

Damage at column cladding

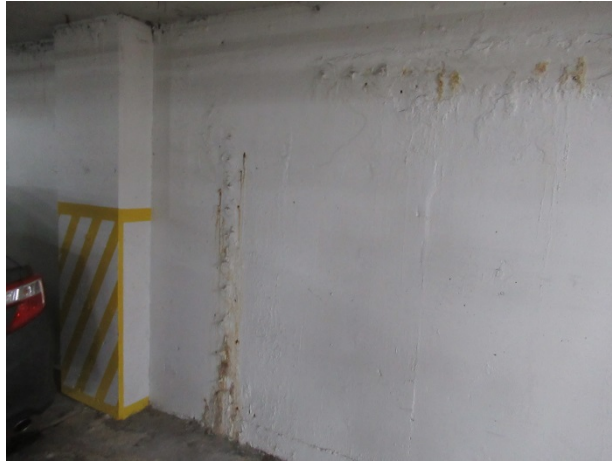
- Racquetball Court (Classified as Operating Budget funded at the direction of Management)
- Seepage Investigation, Garage Lower Level, East and West Walls (Future updates of this Reserve Study will include expenditures for remediation based on the results of the investigation.)

Seepage at garage lower level wall

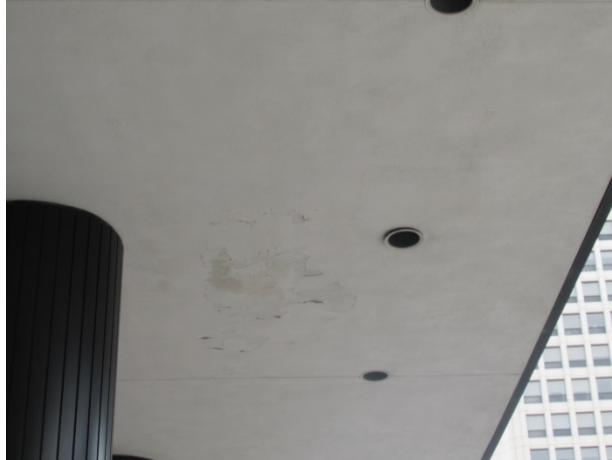
- Soffits (Paint finishes and repairs through the operating budget per Management)

Soffit paint finish deterioration

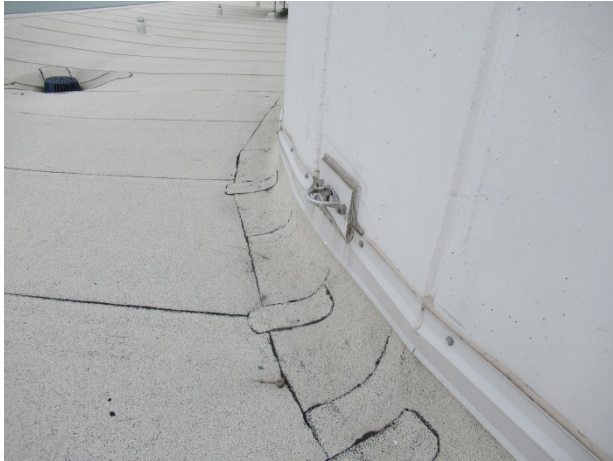
Main level roof system at perimeter termination

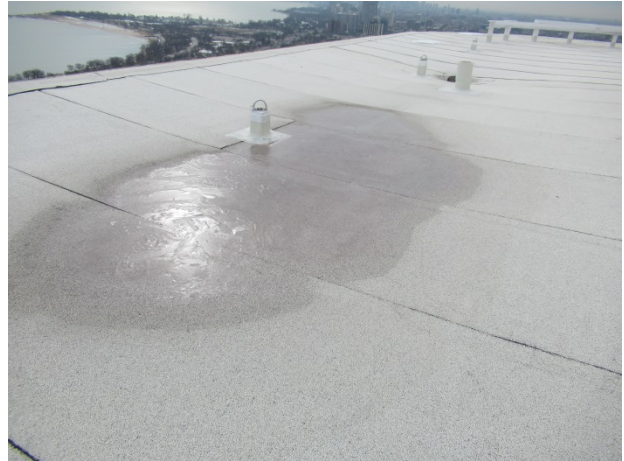
Lack of drainage at main level roof system

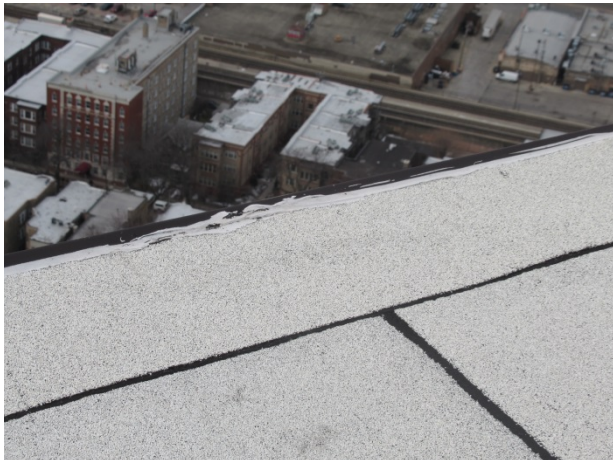
Perimeter sealant at main level roof

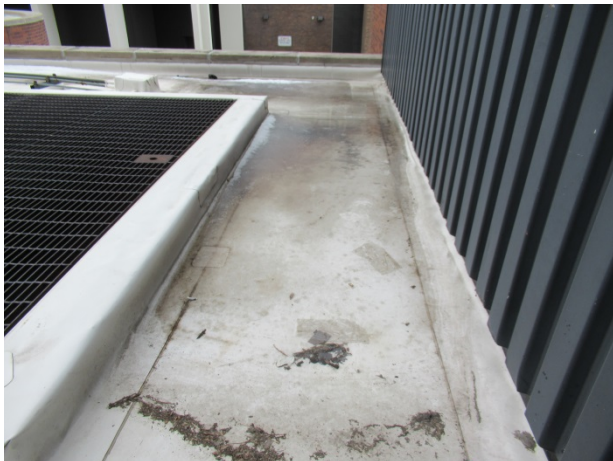
Lack of drainage at roof at 2nd floor northwest

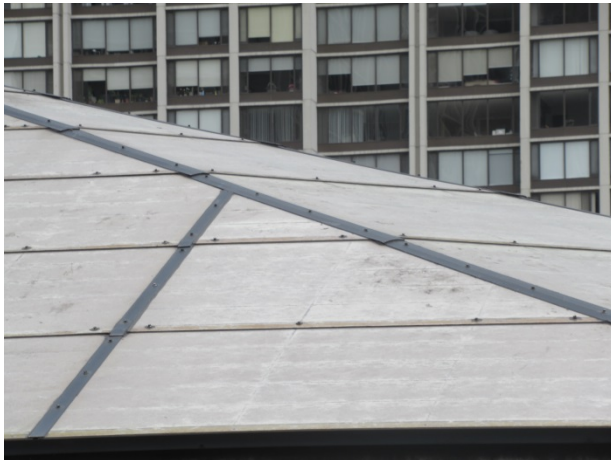
Quantity, History and Condition: The pool enclosure was installed in 1997 and includes approximately 4,700 square feet of *Kalwall* translucent panels with a steel structure. The pool structure exhibits evidence of water infiltration. We include a Building Engineer provided cost to replace the panels in the near term.

Pool enclosure roof system

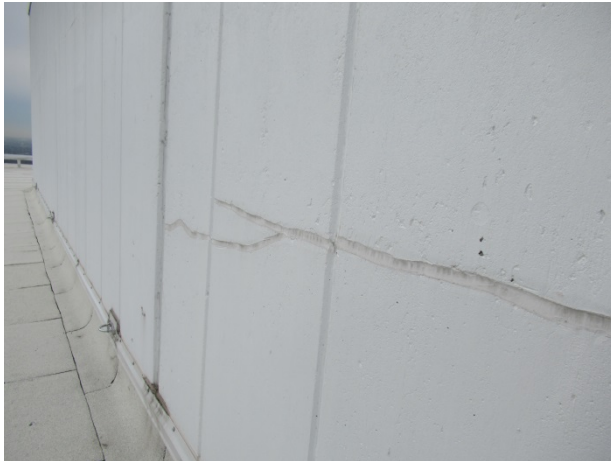
Quantity, History and Condition: The Park Tower mechanical penthouse exterior includes approximately 7,000 square feet of concrete façade. The Association completed concrete repairs and coating application in 2018. The concrete exhibits isolated unrepaired cracks.

Repaired cracks at penthouse concrete

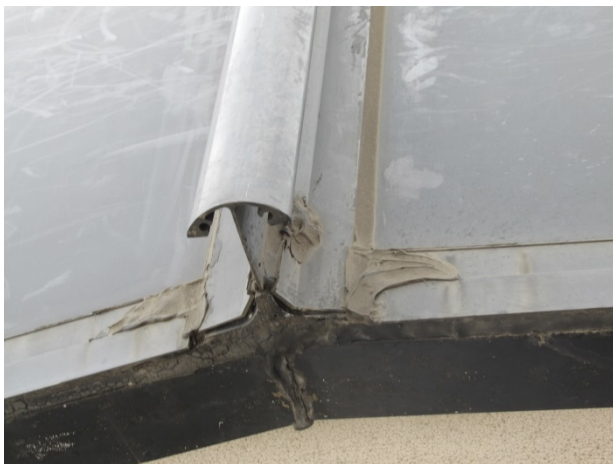
The curtain wall system exhibits areas of sealant deterioration. The spandrel panels and frames exhibit dirt/pollutant build-up.

Sealants at base of vertical mullion

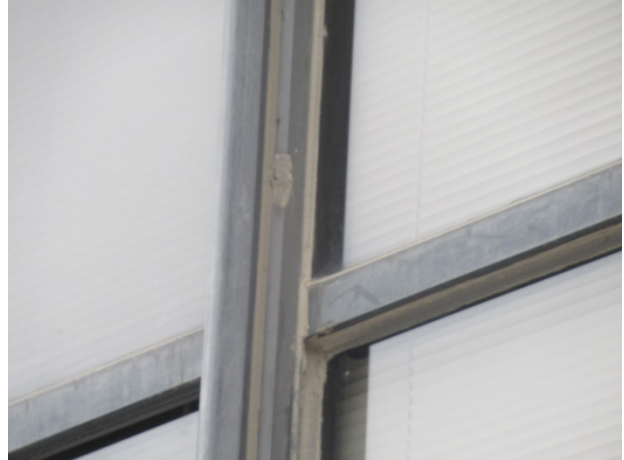
Sealant at metal/glass and metal/metal interfaces

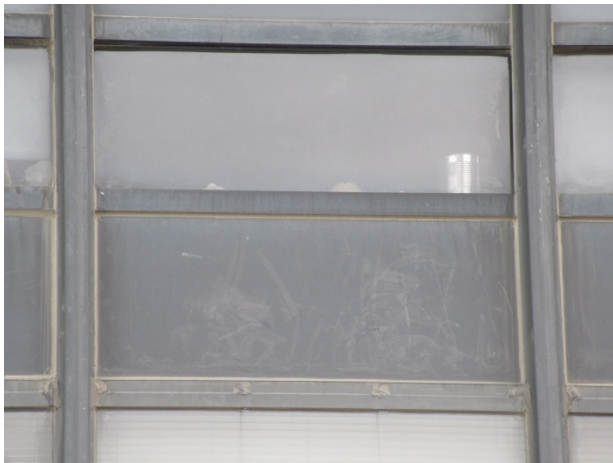
Spandrel panel dirt build-up

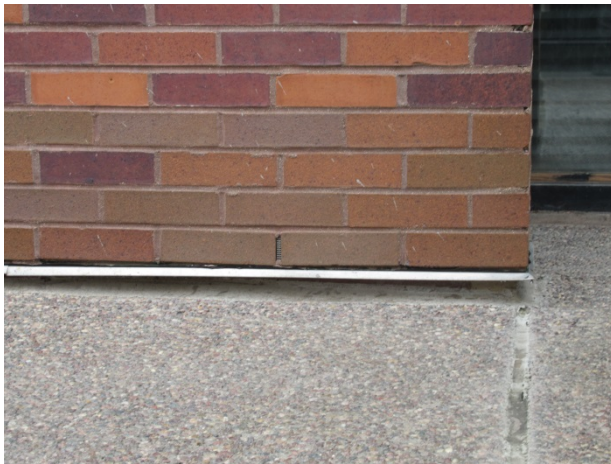
- Face brick masonry
- Caps include varied flashing/weep systems
- Masonry exhibits areas of joint deterioration, cracks and damage at elevations not addressed during the plaza project
- Sealant deterioration is evident at control joints
- Parapet walls exhibit evidence of water infiltration and isolated deflection

Flashing installed at base of masonry wall

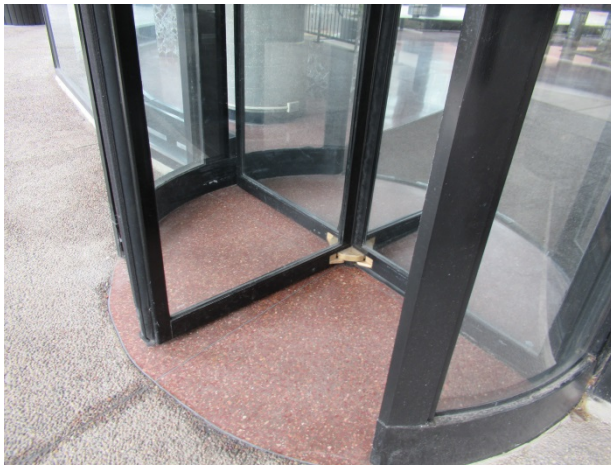
- Lobby, Revolving Doors - two total, likely original with a varied history of repairs and component replacements
- Lobby, Party Room and Weight Exercise Room - 4,300 square feet of single pane aluminum frame systems at the 1st and 2nd Floors, primarily original
- 2nd Floor Walkway and Aerobic Exercise Room - 2,100 square feet of dual pane aluminum frame systems, likely date to 1997, isolated seal failure is evident
- Pool - 1,700 square feet of dual pane aluminum frame systems, sliding glass doors, fair condition with seal failures evident
- Mall - 1,000 square feet of single pane aluminum frame systems at entrances and commercial unit windows, primarily original
- Mall, Skylight - dual pane aluminum frame system, reported satisfactory condition

Lobby revolving door

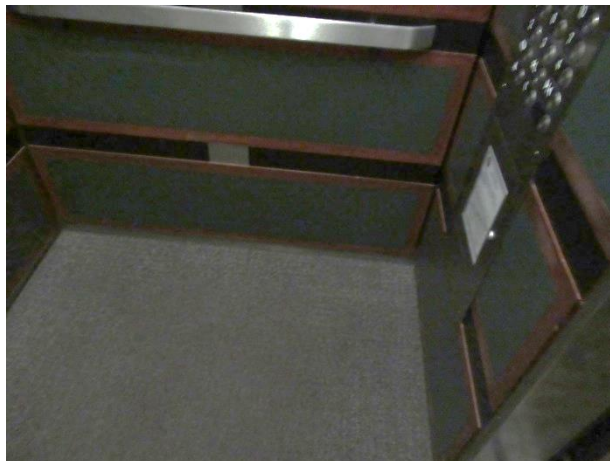
- Traction, Passenger – four elevators, Association refinished the walls in 2014, we include a Management provided cost to replace the finishes in the near term
- Traction, Service – two elevators, finishes vary in age
- Hydraulic, Garage – two elevators, finishes are in fair condition

Traction passenger elevator cab finishes

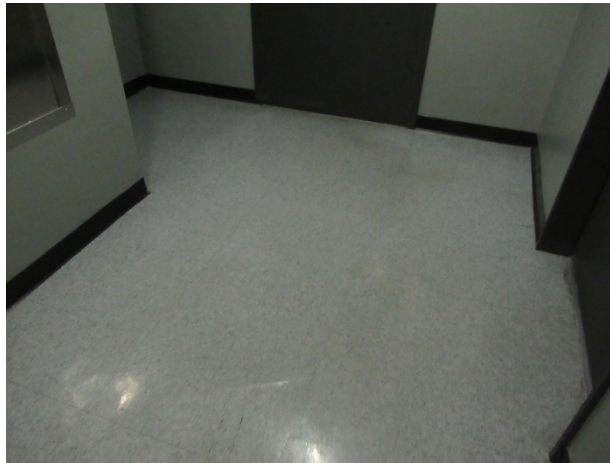
Condition: Fair overall

Flooring at service elevator foyer

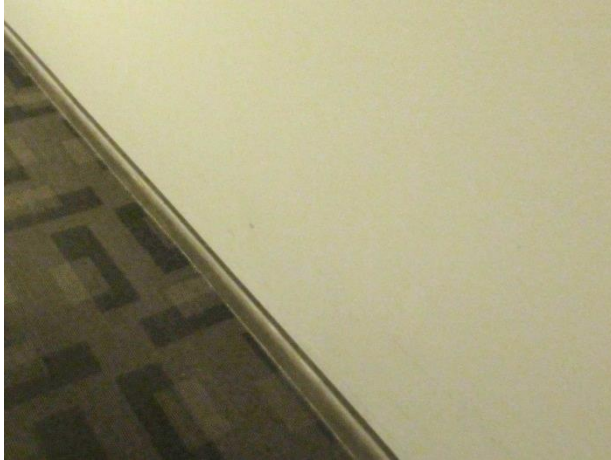
Condition: The paint finishes exhibit areas of scuffs. The wall coverings exhibit areas of damage and separation at seams.

Typical scuff at hallway wall

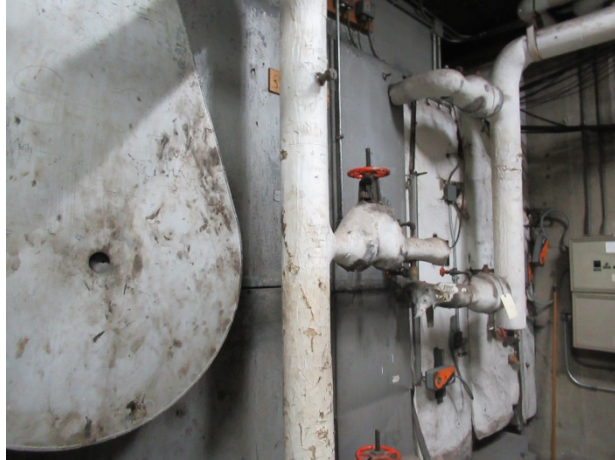
Conditions: Reported satisfactory (An exception is the dampers. The Building Engineer informs us of the likely need to replace several dampers in the near term.)

Corridor air handling unit

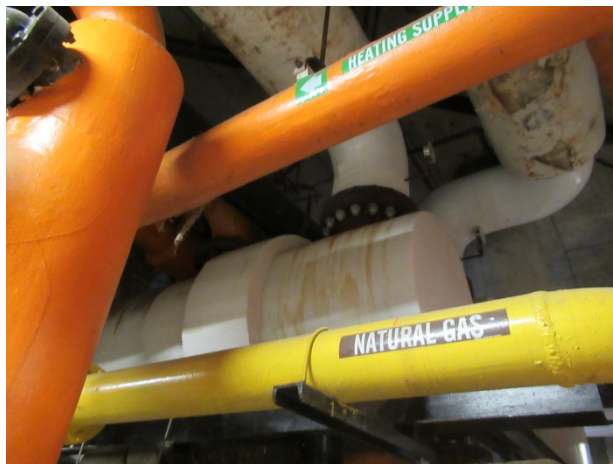
Condition: Reported satisfactory (The Building Engineer informs us that deferral of complete replacement of the heat exchangers is reasonable based on their current operation.)

Heat exchanger for residential unit heat

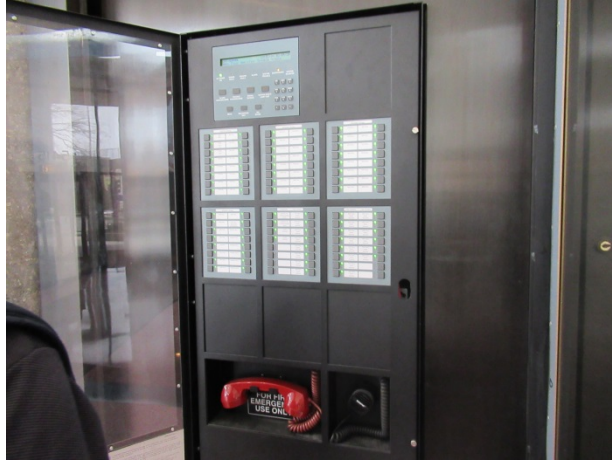
Conditions: Reported satisfactory

Central control panel

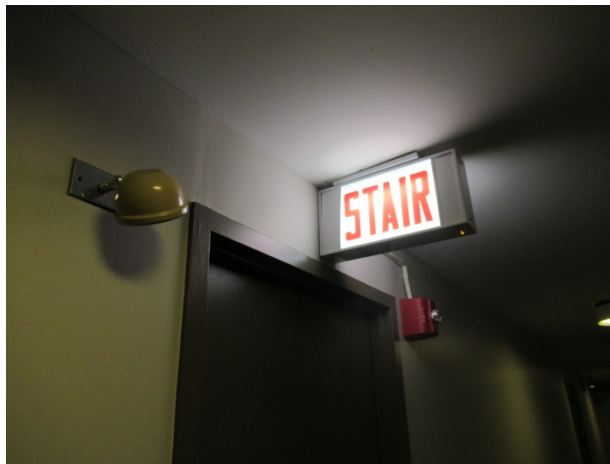
Condition: Reported satisfactory

Fixtures at hallway

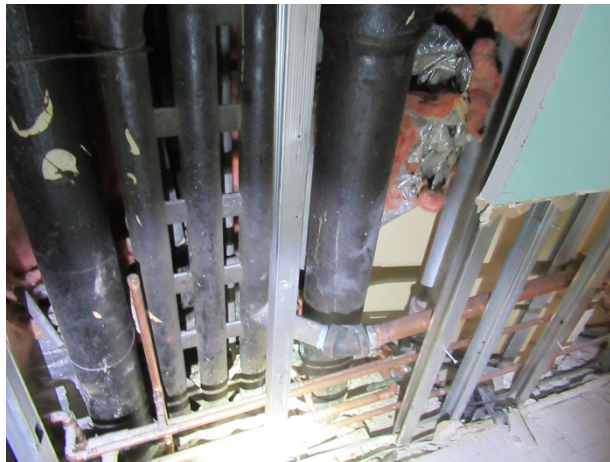
- Domestic Water, Supply and Return – The supply and return galvanized steel domestic water risers are original. The Association began replacement of the domestic hot water risers in 2010 due to leaks and occlusions. The domestic hot water riser replacement program includes the following:

- Insulation installation
 - Replacement of damaged finishes and cabinets in the unitsWe include Management provided costs in the near term to replace the remaining original domestic hot water risers. Management and the Building Engineer inform us that the domestic cold water pipe risers are in satisfactory condition. The Building Engineer does not report a recent history of domestic cold water, waste or vent pipe failures.

Domestic water system risers

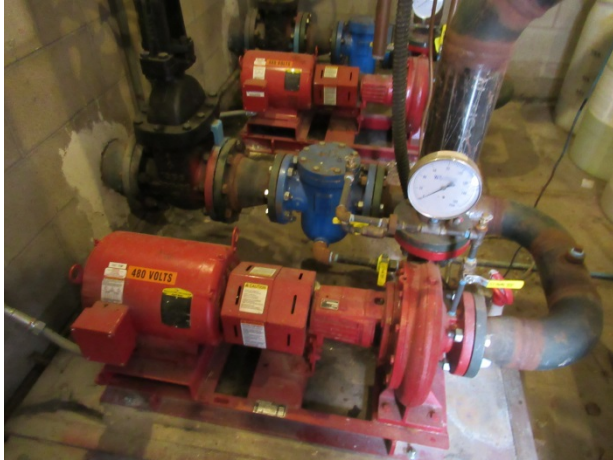
Pumps for commercial cooling system at cooling tower

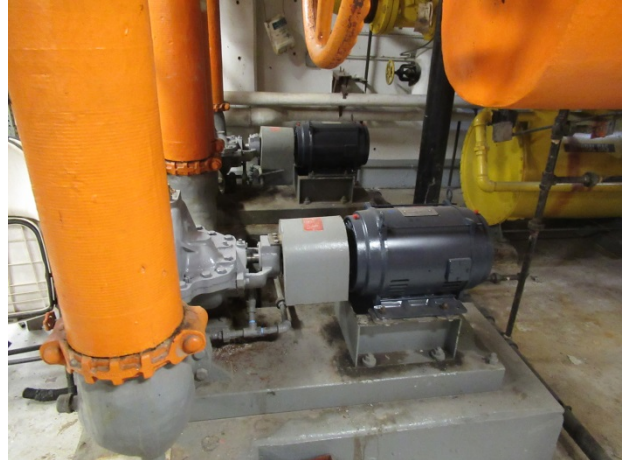
Pumps for commercial building heating system

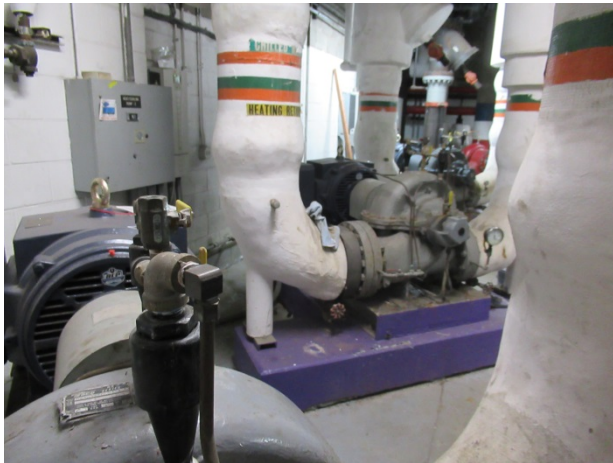
Dual temperature/fan coil loop pumps

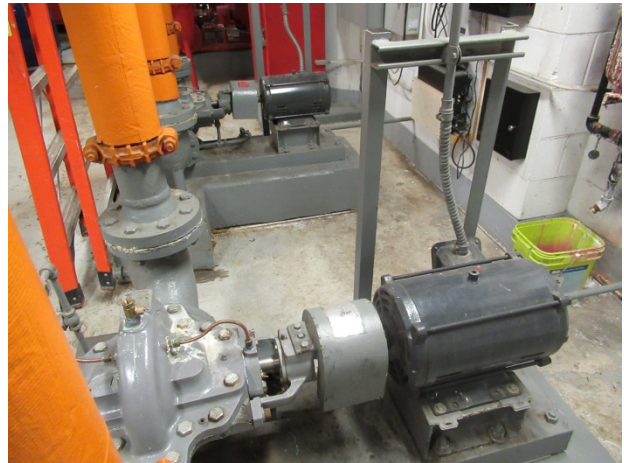
- Building Heating, Residential, Fin Tubes - 10-HP, two each, motors likely recently replaced, we include an expenditure for near term replacement per Management

Pumps for fin tube radiators

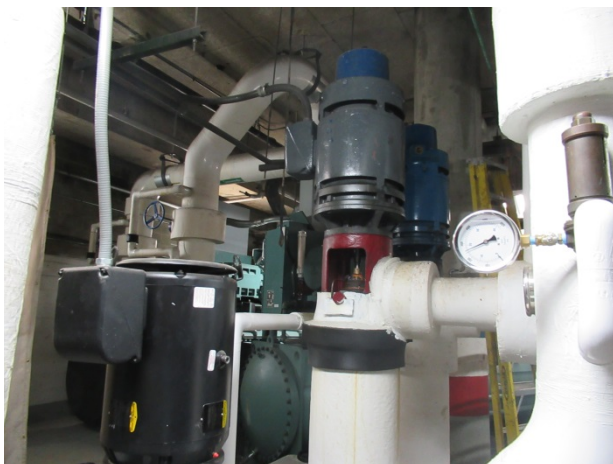
- Domestic Cold Water - two 75-HP each, one 45-HP, three total, one pump recently replaced, we include Management provided costs in the near term to replace the remaining two pumps, reported satisfactory

Domestic cold water pumps

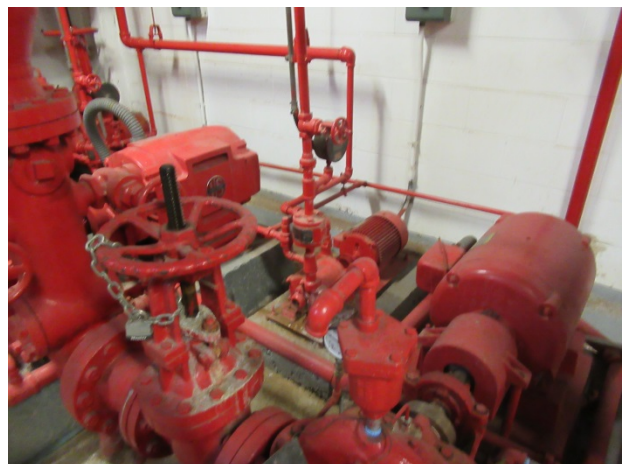
Fire suppression pumps

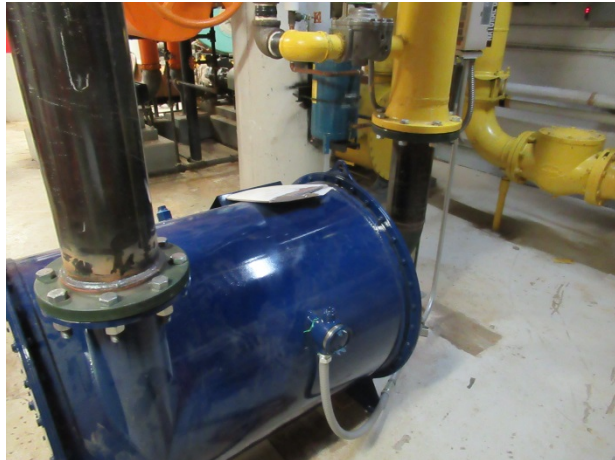
Gas booster pump

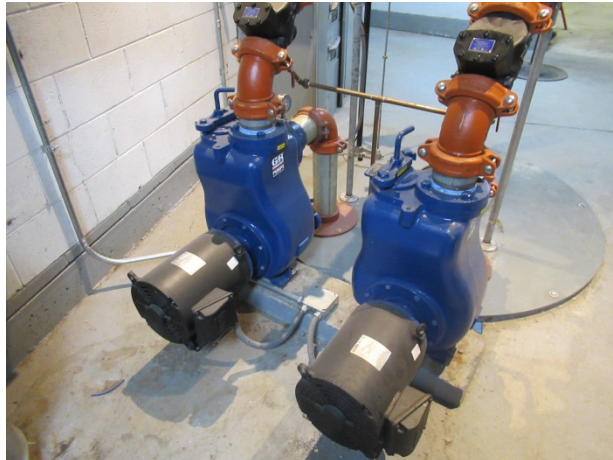
Sewage ejection pumps

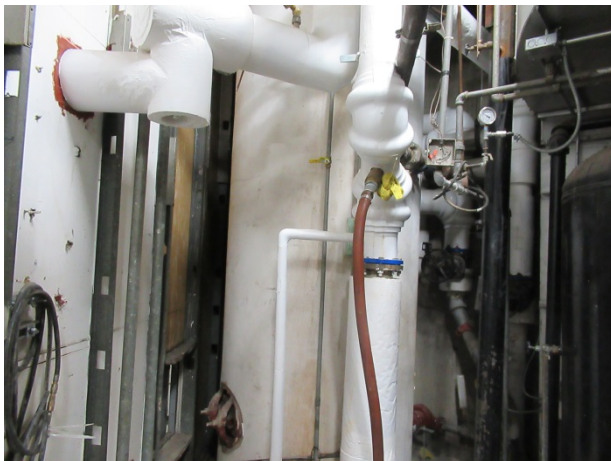
High zone domestic hot water storage tank

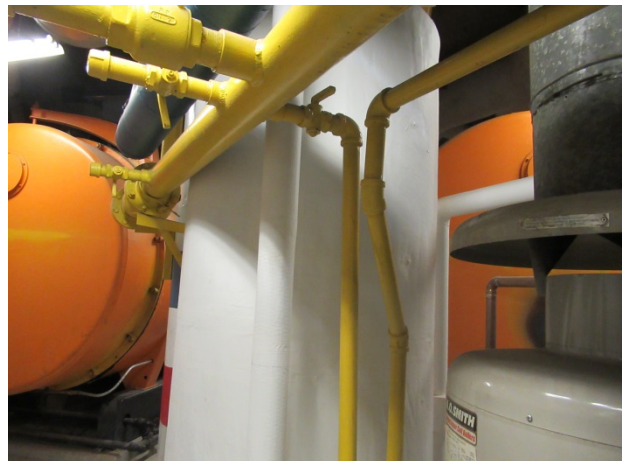
Recently installed storage tank at boiler room

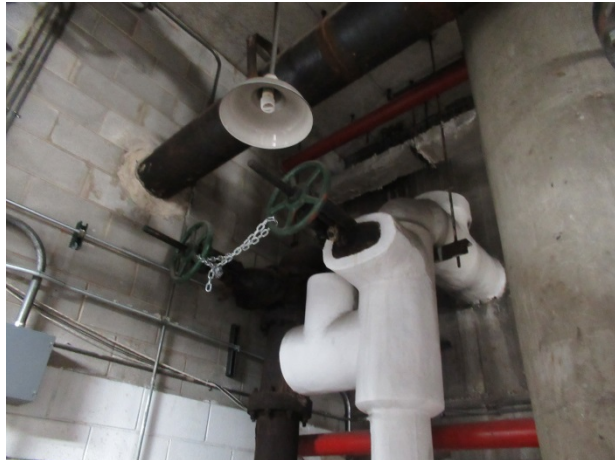
Condition: Reported satisfactory (An exception includes a large diameter valve for the building heating system in the boiler room that will require replacement in the near term, as noted in the narrative “**Heat Exchangers**”.)

Valves at main water connection

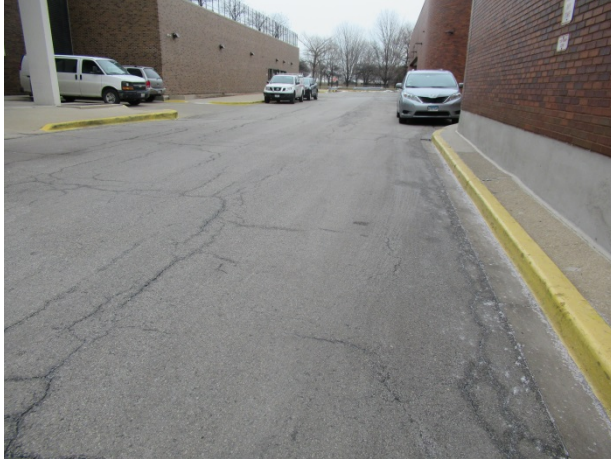
Quantity, History and Condition: The development includes approximately 1,750 square yards of asphalt pavement at the east and north perimeters. The Association shares responsibility of the north pavement with the adjacent building. The pavement was replaced 2013. We note a significant amount of cracks and overall deterioration. We opine that the type and amount of traffic will likely result in a diminished useful life. We include a Management provided cost in the near term to replace the pavement.

Pavement deterioration at north perimeter

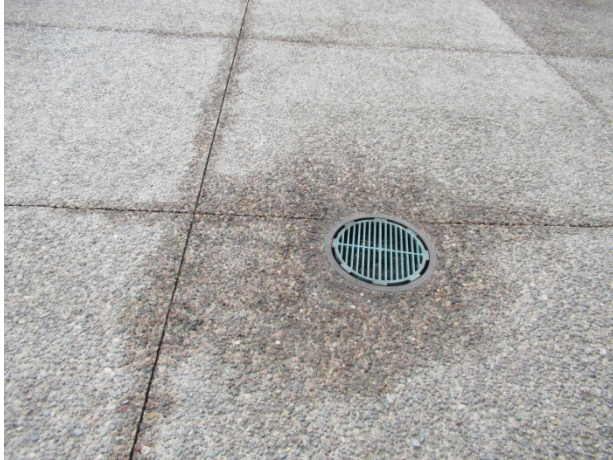
Condition: The concrete exhibits areas of cracks and joint sealant deterioration. The ceiling beneath the plaza exhibits isolated evidence of water infiltration.

Plaza at drain

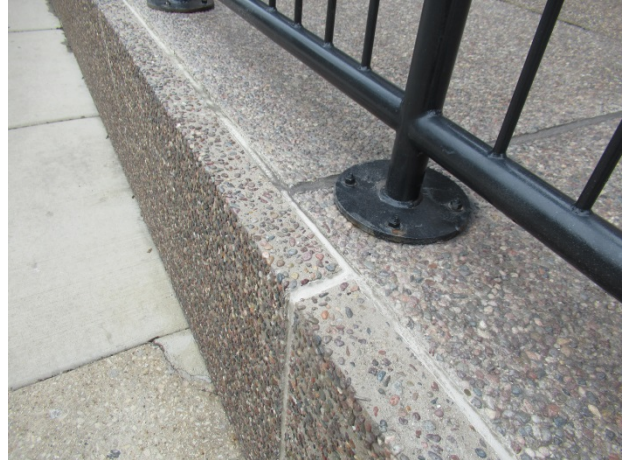
Sealants at plaza joints

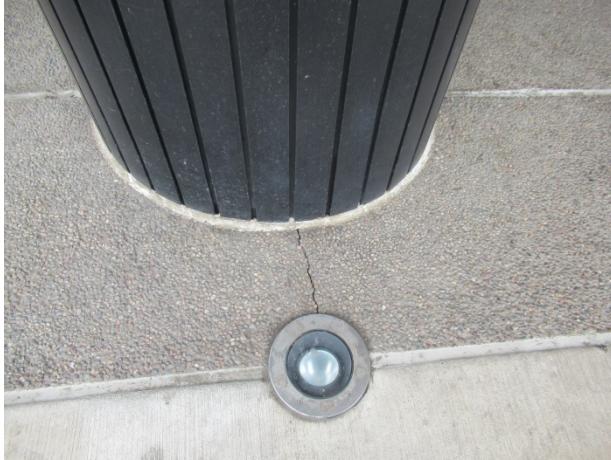
Crack in concrete plaza

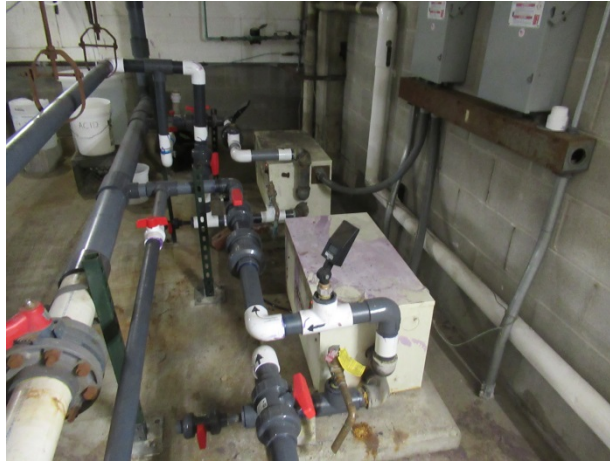
Condition: Conditions vary

Pool mechanical equipment

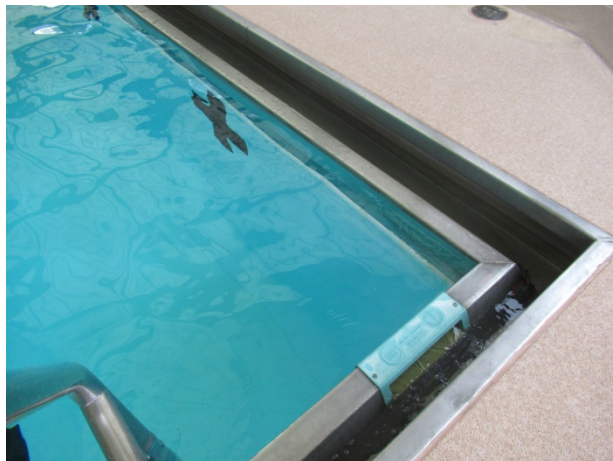
Liner at indoor pool

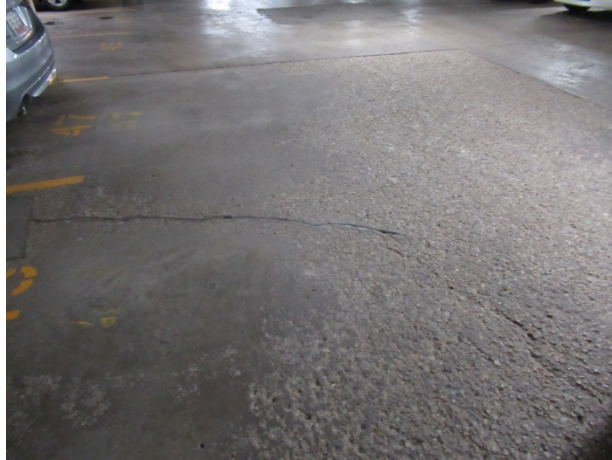
Condition: Conditions vary with areas of cracks and surface spall evident (We note near term repairs in the narrative “**Concrete, Elevated Floor**”).

Concrete floor cracks and surface spall

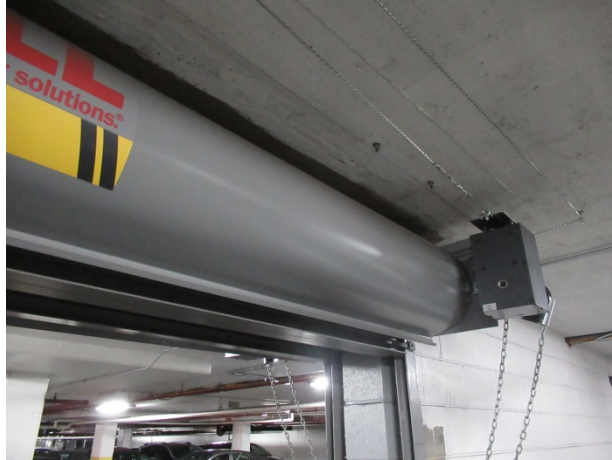
Condition: Reported satisfactory

Garage fire door

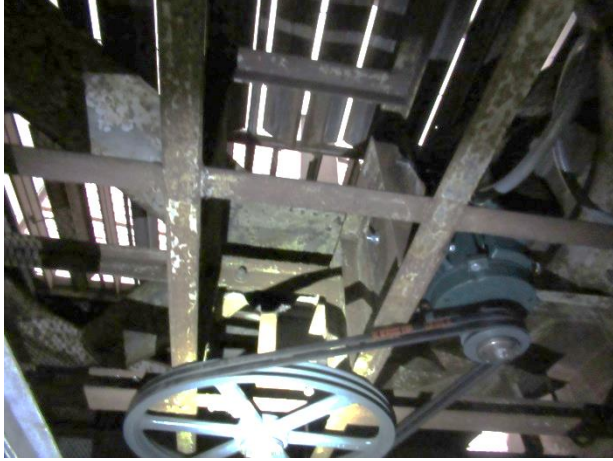
Garage exhaust fan

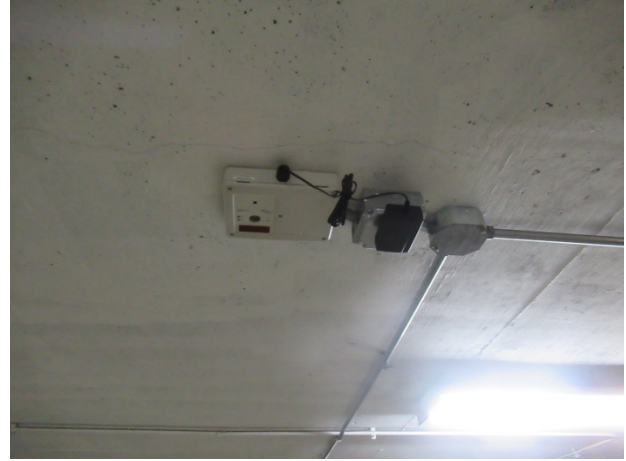
Garage CO detector

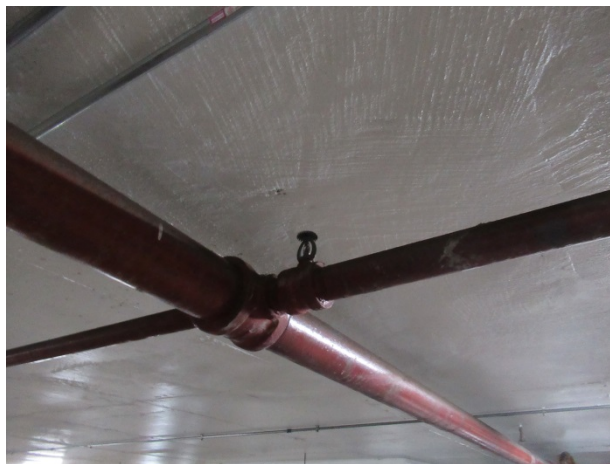
Condition: Reported satisfactory

Fire suppression system pipes and head

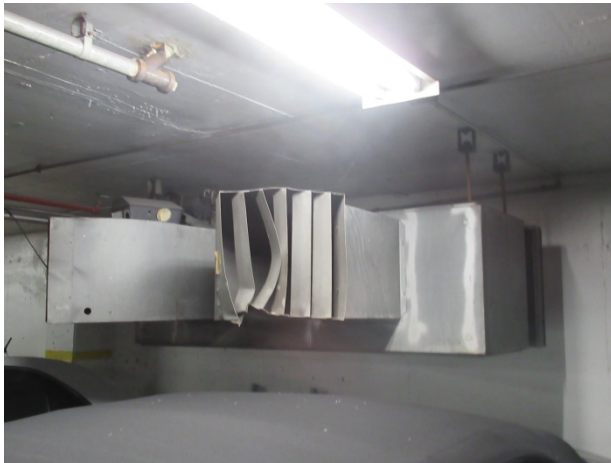
Original garage heater

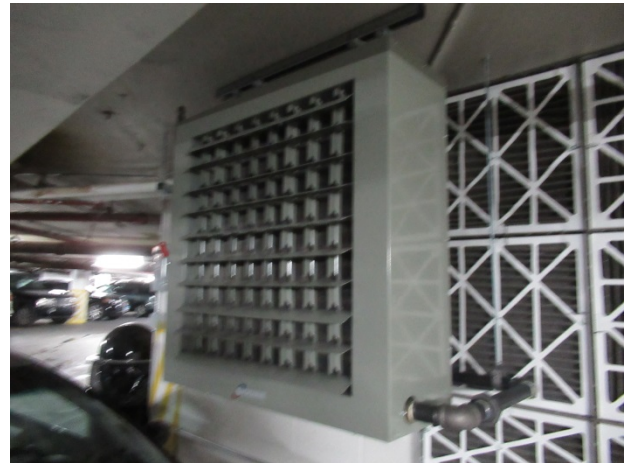
Recently installed unit heater
