FULL RESERVE STUDY

Park Tower Condominium Association

Chicago, Illinois
February 13, 2020

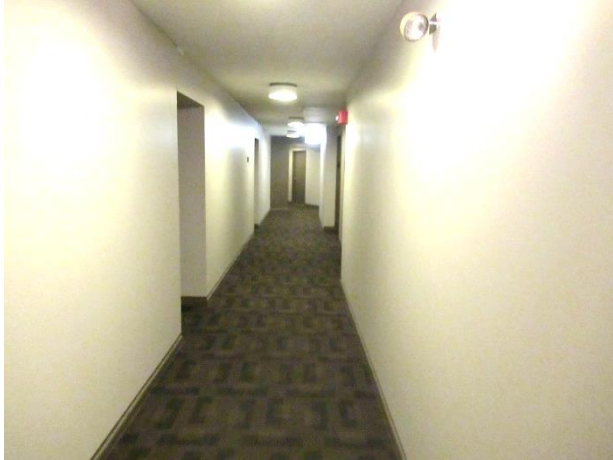
Condition: Fair overall with areas of stains, deterioration at seams and wear evident

Residential hallway

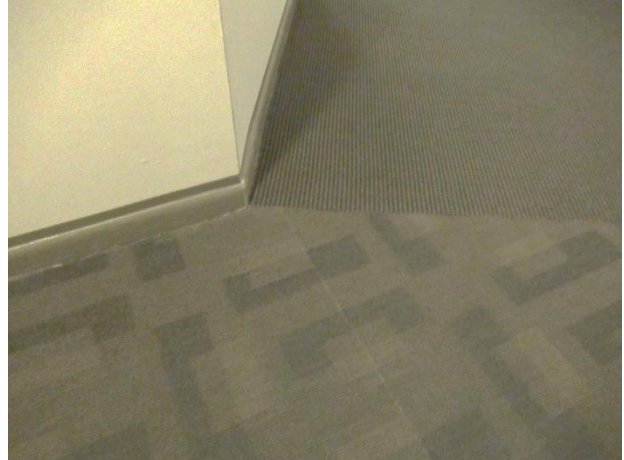
Carpet at residential hallway

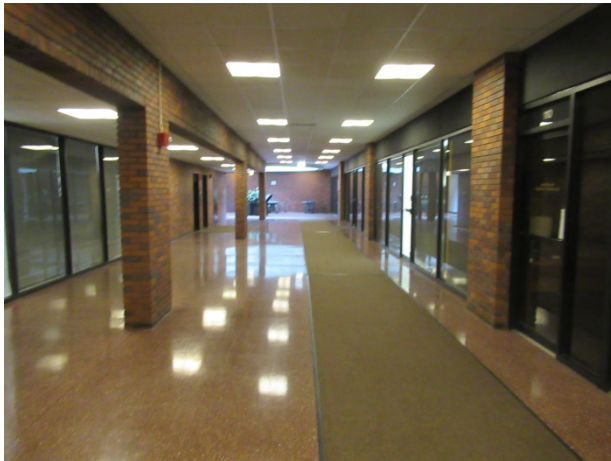
- Corridors – 5,500 square feet of terrazzo floor and ceiling tile system with light fixtures, the ceiling tile system exhibits areas of stains/damage
- Market (Store) – concrete floor, ceiling tile system, light fixtures and paint finishes, the Association removed the floor coverings in 2016, the ceiling tile system exhibits areas of stains/damage
- Office – renovated in 2012
- Rest Rooms – two total, renovated in 2019

Mall corridor

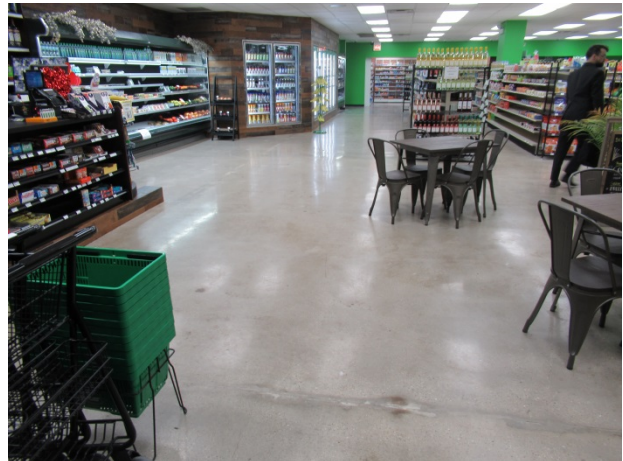
Market at mall

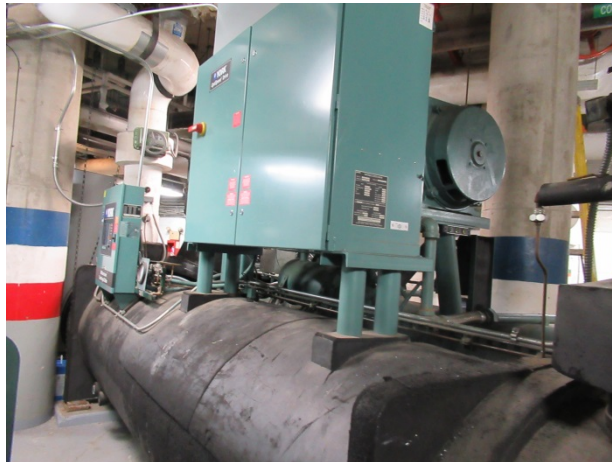
Chiller

Component Detail Notes: The centrifugal chillers provides chilled water for air conditioning the building and use R-123 refrigerant. Per the EPA, production of new equipment utilizing R-123 will cease as of January 1, 2020, and no production or importing of any HCFC refrigerants for equipment servicing will be allowed after January 1, 2030. While R-123 is still available, the cost will likely increase as phase-out begins. Since chillers have a useful life of 25 to 35 years, the Association should consider replacement with equipment that does not utilize the refrigerants mentioned above.

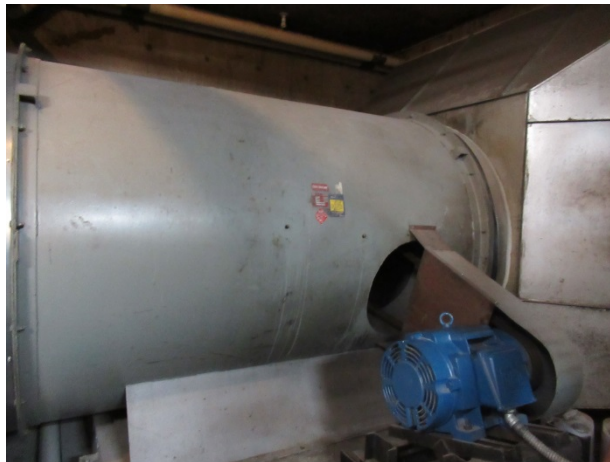
History: The fans are original with a varied history of repairs and component replacements. The Association completed component replacements and modifications to the rest room fan in 2015. We include a Management provided cost in the near term for similar modifications, including vibration eliminators, to the kitchen fan in the near term.

Exhaust fan

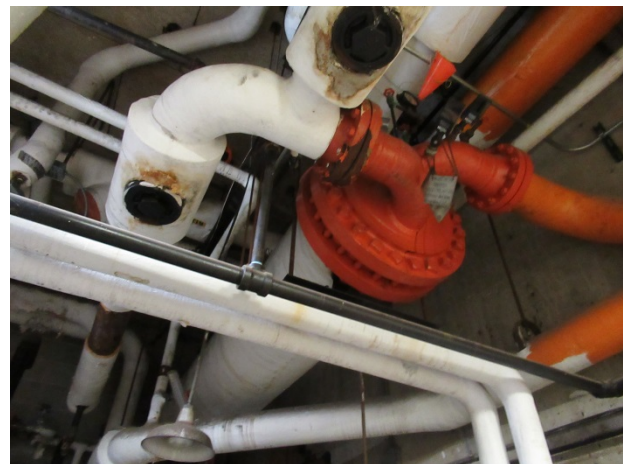
Condition: Reported satisfactory (The Building Engineer informs us that deferral of complete replacement of the heat exchangers is reasonable based on their current operation.)

Heat exchanger for commercial heat

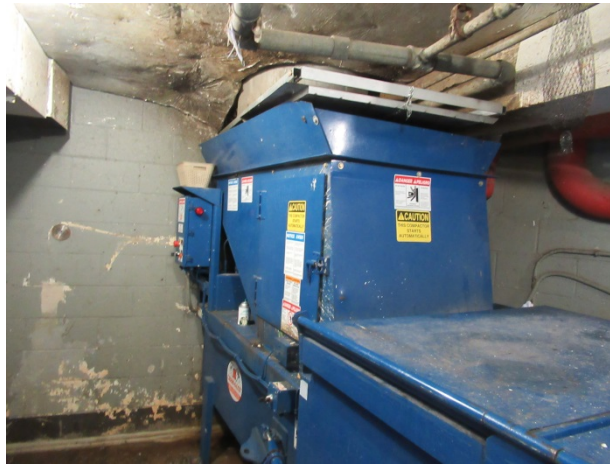
Condition: Reported satisfactory without operational deficiencies

Trash compactor

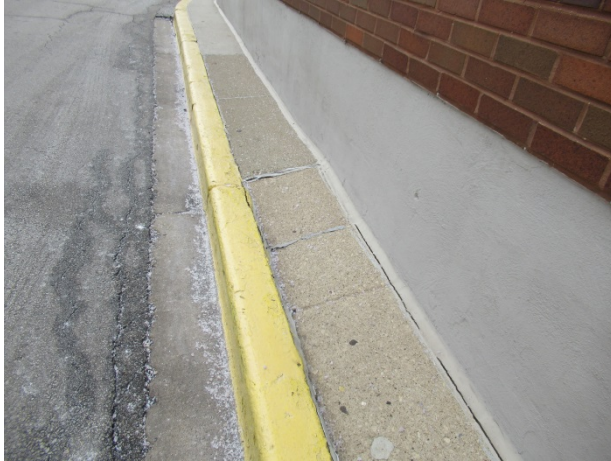
The concrete varies greatly in condition. We therefore include similar periodic allowances for partial replacements as the development ages.

Concrete settlement

Component Detail Notes: The development includes various on-grade concrete at the site, including sidewalks, pavement and curbs/gutters. We include a Management provided cost for partial replacement of the concrete at the north, northwest and northeast perimeters.

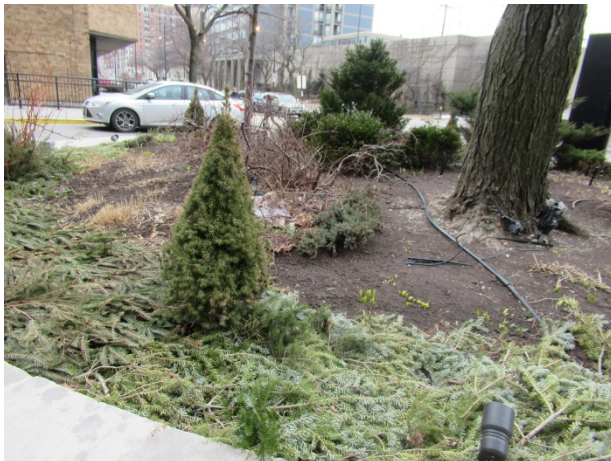
Planter at circle driveway

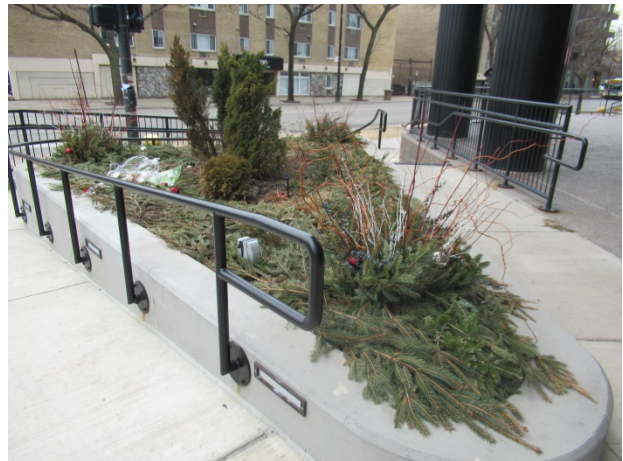
Planter at lobby entrance area

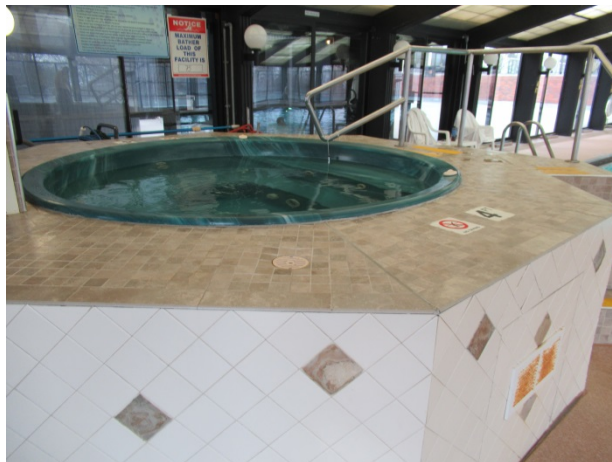
Condition: The hot tub insert is in reported satisfactory condition.

Hot tub

History: Insert replaced in 2007. We include a Management provided cost to rebuild the surrounding platform and to replace the post lighting in the near term.

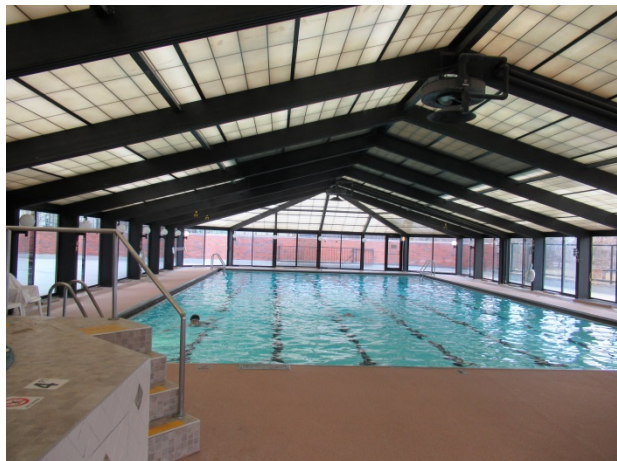
Indoor pool

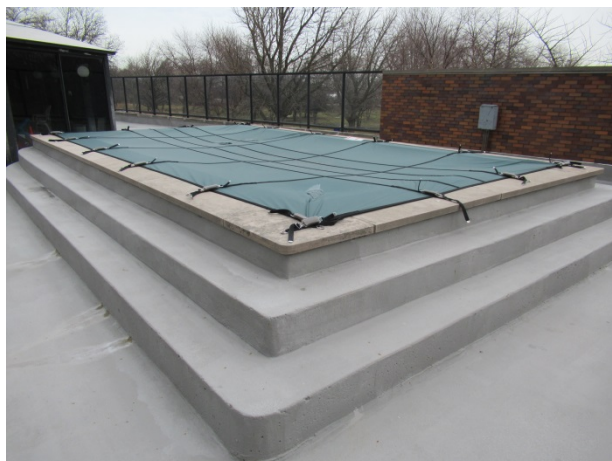
Outdoor pool

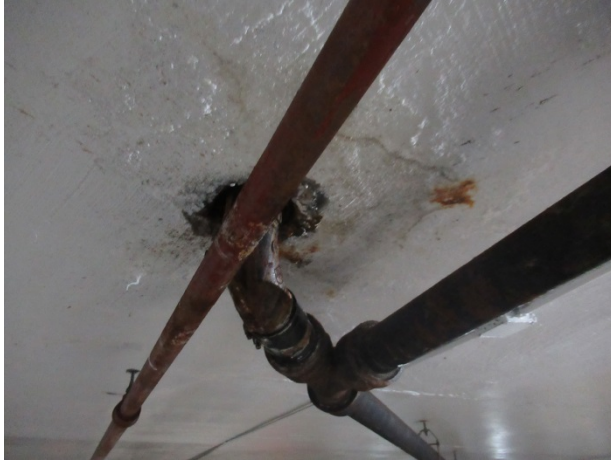
Evidence of water infiltration beneath elevated garage floor
